DEPARTMENT OF TRANSPORTATION

Federal Aviation Administration

[Docket No. 2001-SW-13-AD]

Airworthiness Directives; Bell Helicopter Textron, Inc. Model 47B, 47B-3, 47D, 47D-1, 47G, 47G-2, 47G2A, 47G-2A-1, 47G-3, 47G-3B, 47G-3B-1, 47G-3B-2, 47G-3B-2A, 47G-4, 47G-4A, 47G-5, 47G-5A, 47H-1, 47J, 47J-2, 47J-2A, and 47K Helicopters

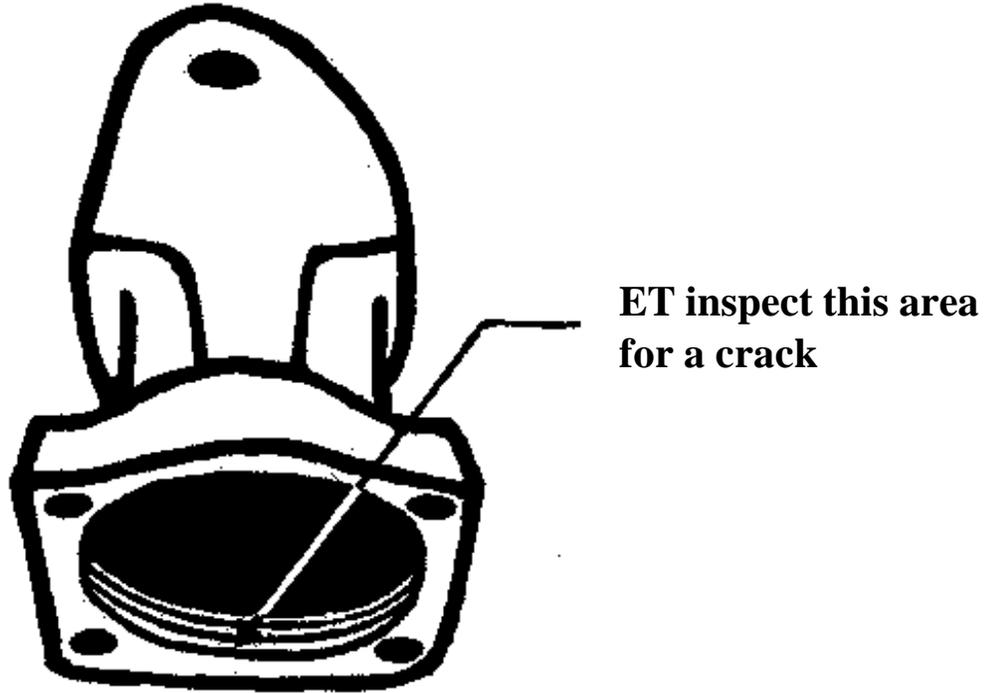
Figure 1, Appendix 1

1.1 The inboard inside diameter machined threads (reference figure 1).

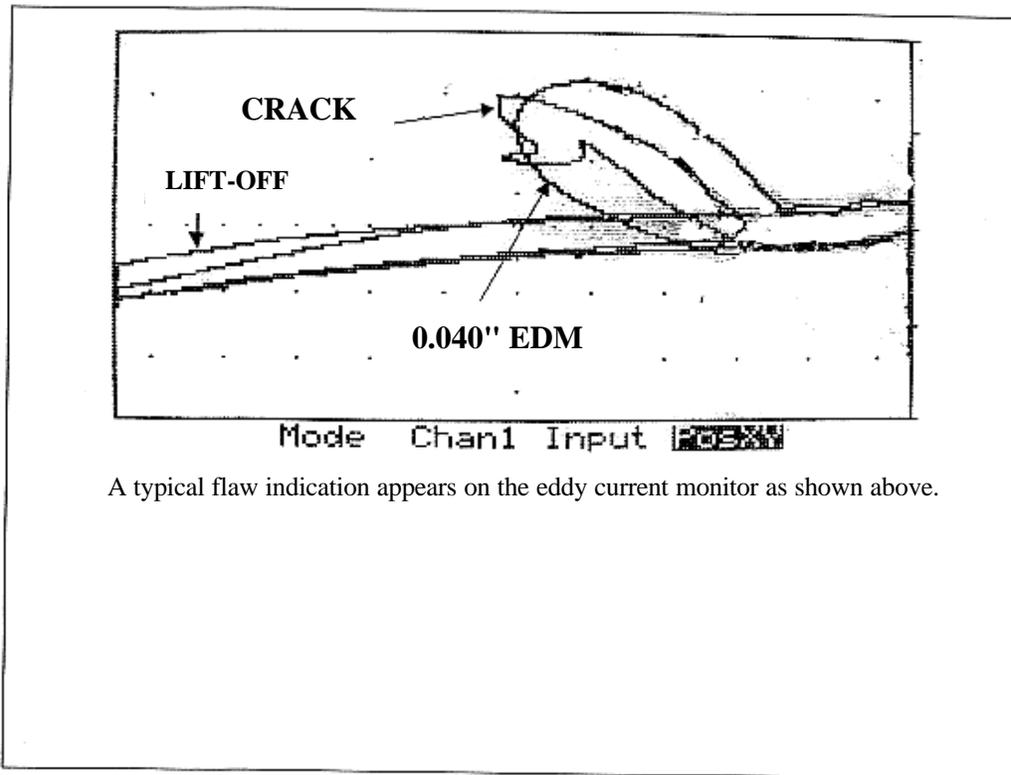
Figure 2, Appendix 1

6.1 Place the probe into the threaded area and slide it in the same direction as was done on the standard while monitoring the screen for root cracks. Moving the probe in the same direction produces a repeatable display that allows for more accurate flaw size determination. Scan the probe along each individual thread until all the threads are inspected. (See Figures 2 and 3.)

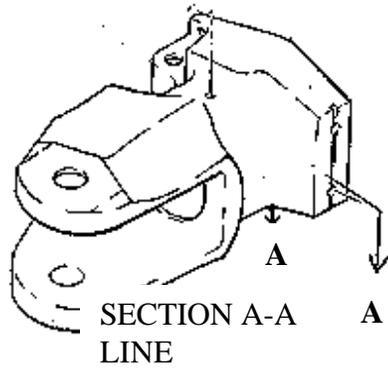
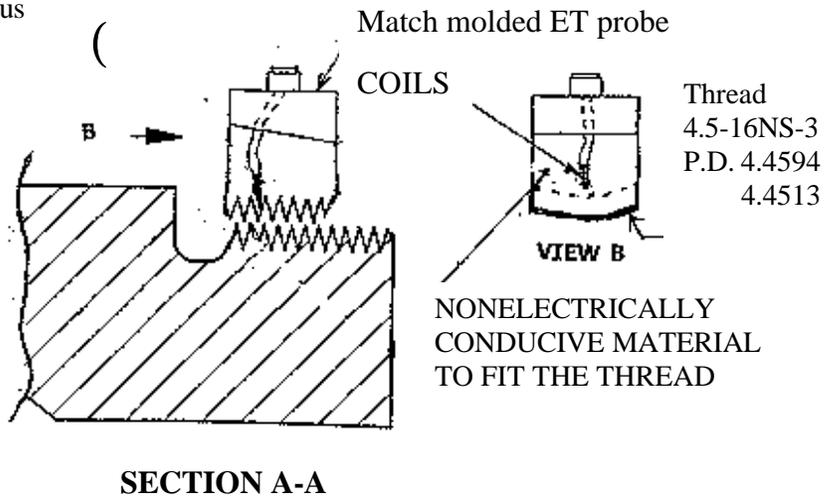
Figure 3, Appendix 1

2.2 Match molded ET probe SPC-193 (100kHz) or equivalent. (See Figure 3.)

A special eddy current probe shaped to fit the thread and containing a coil positioned so that its ferrite core is contiguous with the root of the thread.

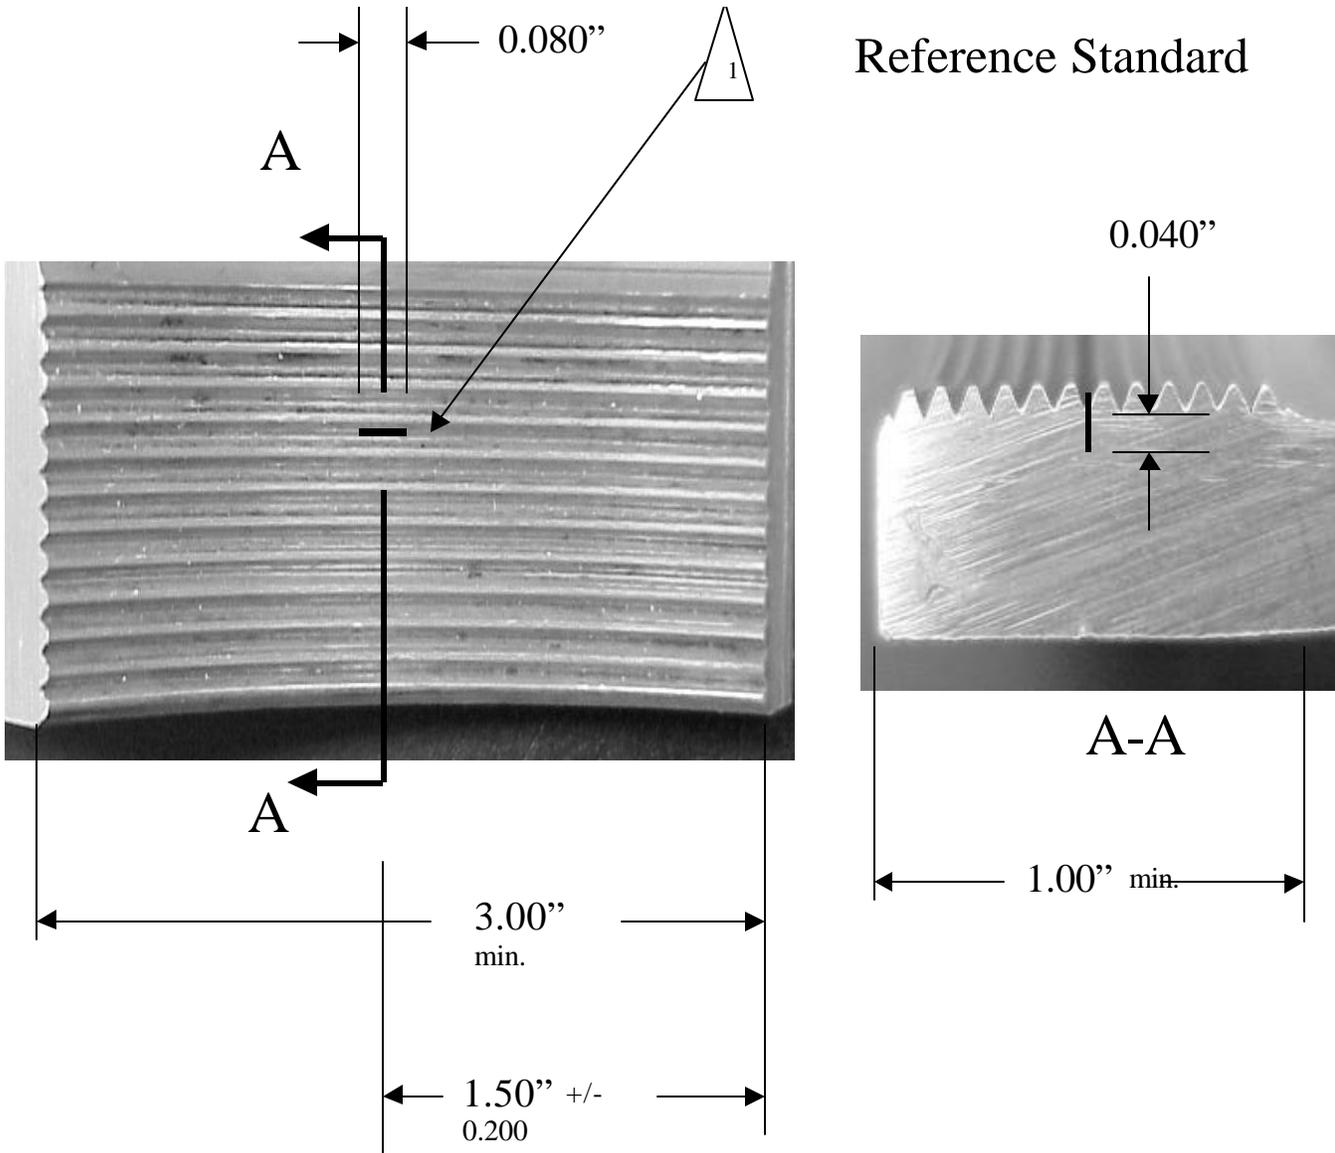
Figure 4, Appendix 1

2.3 Reference standard EC-010-021, or equivalent. (See Figures 4 and 5.)

EDM 1 place only in thread root.
 Notch width shall be 0.004 max.
 All other dimensions to be +/- 0.004 from indicated.

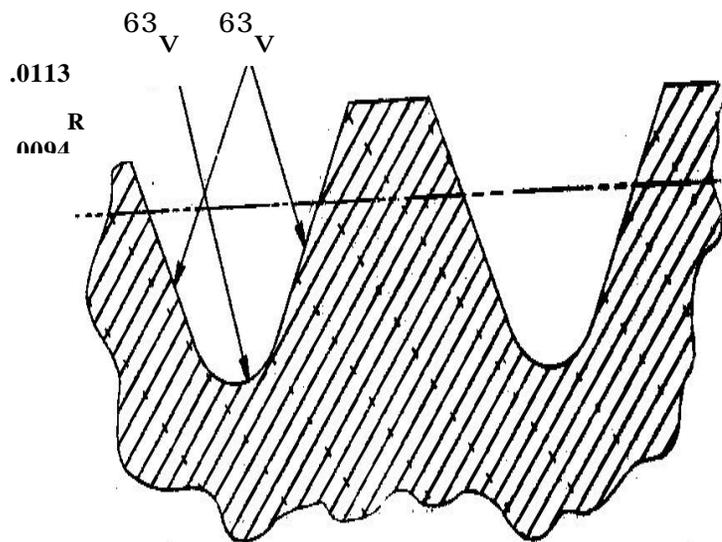
Figure 5, Appendix 1

1. Standard may be machined from aluminum tube stock.
2. The standard shall contain a minimum of four teeth per the tooth dimensions specified.
3. The EDM notch shall be placed in the center most tooth root as measured across the width of the standards. There shall be no less than two teeth and one root on either side of the EDM notch.

CHAMFER 45 DEG. X .06
4.500 - 16 NS - 3B
THREAD PER
FED - STD. - H28/2
P.D. 4.4675
4.4594
